# Manhole Inspection Summary

Manhole # S19AA\_036MH

Insp Date: **3/11/09 2:02 PM**

**Location** Address: **W LAFAYETTE ST**

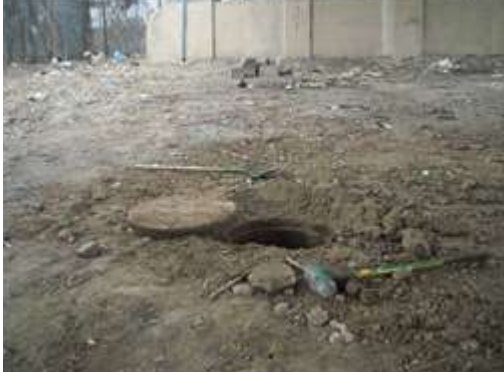
Location View

LOCATED USING METAL DETECTOR -  
EXPOSED USING HAND TOOLS -  
OPENED USING 16LB MAUL AND

SHEETING

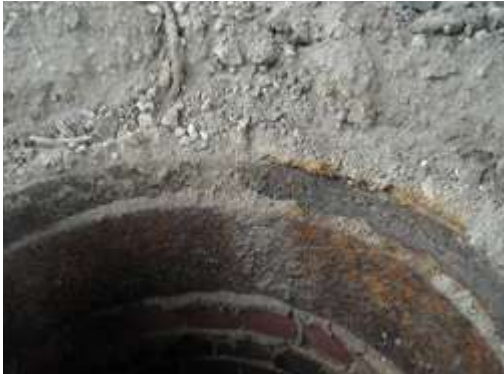
IS NOW BELOW GRADE, SUBJECT TO  
INFILTRATION FROM SHEETING AND  
OR PONDING. WILL BE REBURIED

Comments **LOCATED BURRIED BENEATH LAFAYETTE ST BRIDGE. EXPOSED USING HAND TOOLS. OPENED USING 16LB MAUL AND PICKAXE. INSPECTION COMPLETE. MH NEEDS TO BE RAISED TO PREVENT BEING BURRIED AGAIN DUE TO EROSION OF SOIL IN VICINITY.**

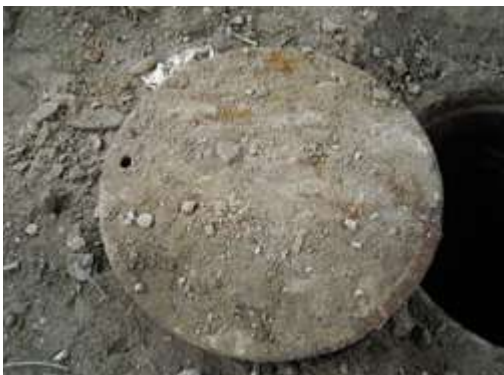
Defect 1

WORN COVER CORRODED AND  
COVERED WITH CEMENT

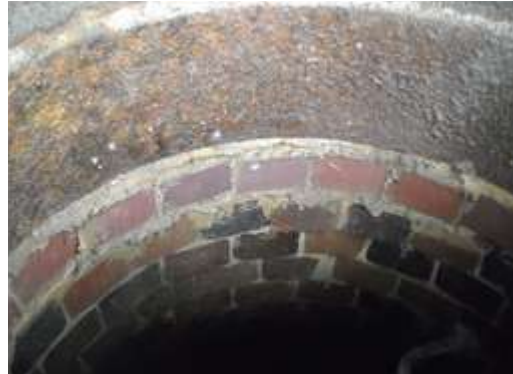
Defect 2

CHIMNEY ADJUSTMENT 4"

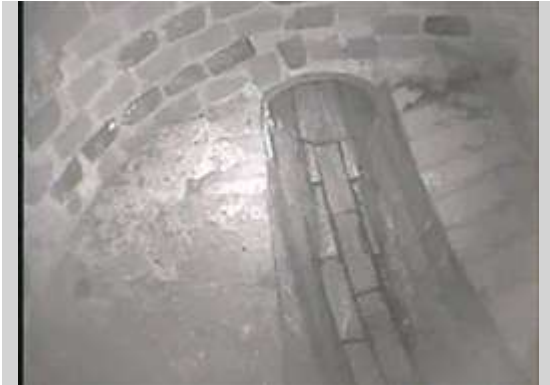
12 O'Clock Outflow

12 in. Circular Gravity Sewer  
Pipe Out @ 12 O'Clock

Pipe Height: **12** (in.) Rod and Bar (Angled)  
Pipe Material: **Clay** ☐ Pipe Lined  
Invert Depth: **18.34** (ft.) Flow Characteristics: **Slow**  
Deposits: ☒ None ☐ Mud ☐ Sludge ☐ Debris ☐ Grease  
Silt Depth: (in.) Deposits Extent:  
Infiltration: **None** Pipe Seal Cond: **Sound**

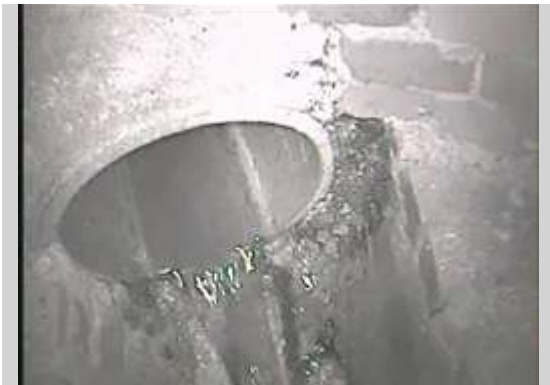
5 O'Clock Inflow

10 in. Circular Gravity Sewer  
Pipe In @ 5 O'Clock

Pipe Height: **10.8** (in.) Rod and Bar (Angled)  
Pipe Material: **Clay** ☐ Pipe Lined  
Invert Depth: **17.12** (ft.) Flow Characteristics: **Fast**  
Deposits: ☒ None ☐ Mud ☐ Sludge ☐ Debris ☐ Grease  
Silt Depth: (in.) Deposits Extent:  
Infiltration: **None** Pipe Seal Cond: **Cracked**
